# Sample Drone EL Inspection Report

Electroluminescence inspection of a utility-scale photovoltaic array

| Document reference | SFA-QE-EL-SAMPLE-01 |

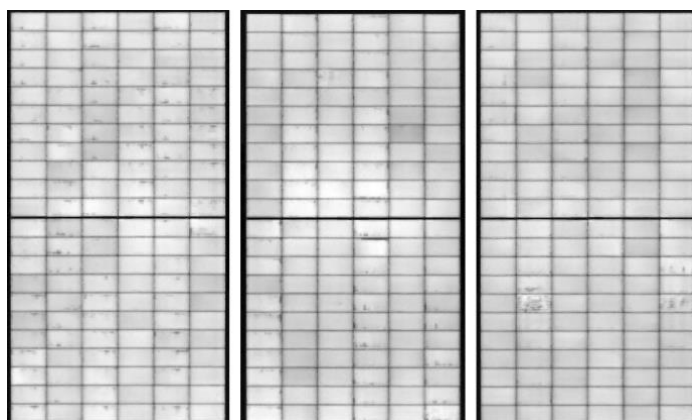
**Finger-defect indications:** 310 modules (3.8% of the measured population). Of these, 276 are in anonymised Regions R05 and R06, representing 89% of this class. This is a useful basis for targeted investigation; it does not establish a common production or installation cause.

The reported pattern comprises short dark features associated with the cell fingers. The source records one to three affected cells on 207 of the 310 modules; some have ten or more. R05 contains 116 affected modules (18.0% of its assessed population), and R06 contains 160 (23.8%).

Figure 1. Source examples classified as finger defect. Individual asset identifiers are omitted.

| Order | Reported finding | Recommended next action | Close-out evidence |
|---|---|---|---|
| 2 | Finger-defect indications<br>310 modules; 276 in R05/R06 | Review representative source images and acquisition consistency. Compare traceability and batch/installation records where available. Select modules for further electrical testing if warranted. | Verified classification and investigation outcome |

**Interpretation and action:** the regional grouping warrants targeted image review and checks of batch, installation and acquisition records. A common cause has not been established. The associated power impact is unquantified.

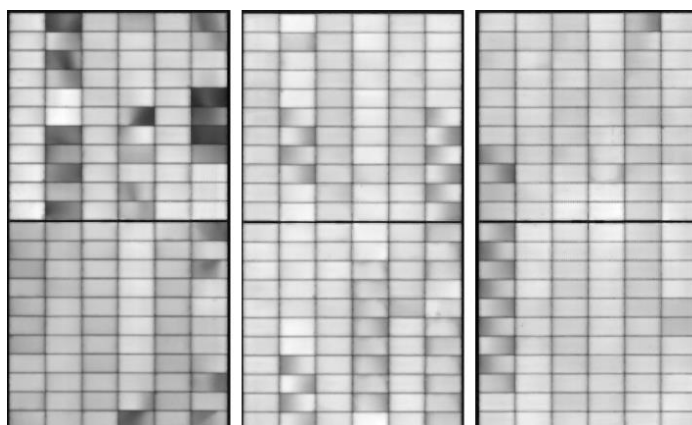
Uneven EL emission is reported across eight regions. R09 has the largest count, with seven modules. Potential explanations should be evaluated using the source imagery, test conditions and appropriate follow-up measurements.

Figure 2. Source examples showing non-uniform cell emission.

**Next action:** review representative cases and use suitable I-V testing if an assessment of associated output loss is required.

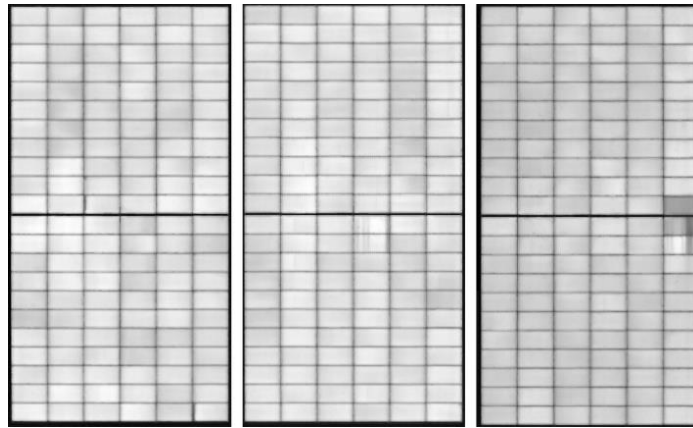
The source classifies these as soldering defects. Four occur in R04, one in R06 and one in R08. The images show dark bands associated with busbar or interconnection regions. This pattern suggests an interconnection issue for investigation; it does not confirm a production-stage soldering failure.

Figure 3. Source examples labelled as soldering defects / dark busbars.

| Order | Reported finding | Recommended next action | Close-out evidence |
|---|---|---|---|
| 2 | Dark busbar indications<br>6 modules; 4 in R04 | Review the EL pattern and investigate possible interconnection issues. Correlate with appropriate physical and electrical checks before attributing cause. | Inspection/test record linked to each module |

**Next action:** verify the classification in the original images and correlate with appropriate physical and electrical checks. The grouping in R04 should be recorded, while recognising that six cases are insufficient to establish a shared cause.

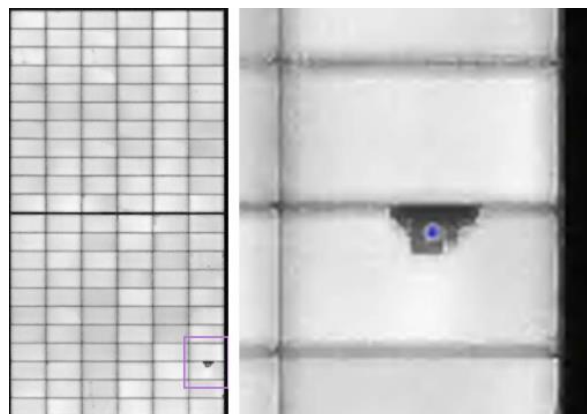
One module in R04 shows a localised dark area extending from a cell edge. No mechanism is assigned. The original string and position reference is withheld in this sample.

Figure 4. Source module view and enlarged detail of the localised dark area.

**Next action:** review the source image, retain a baseline and investigate further if corroborating electrical evidence or subsequent change warrants it. No power impact has been quantified.

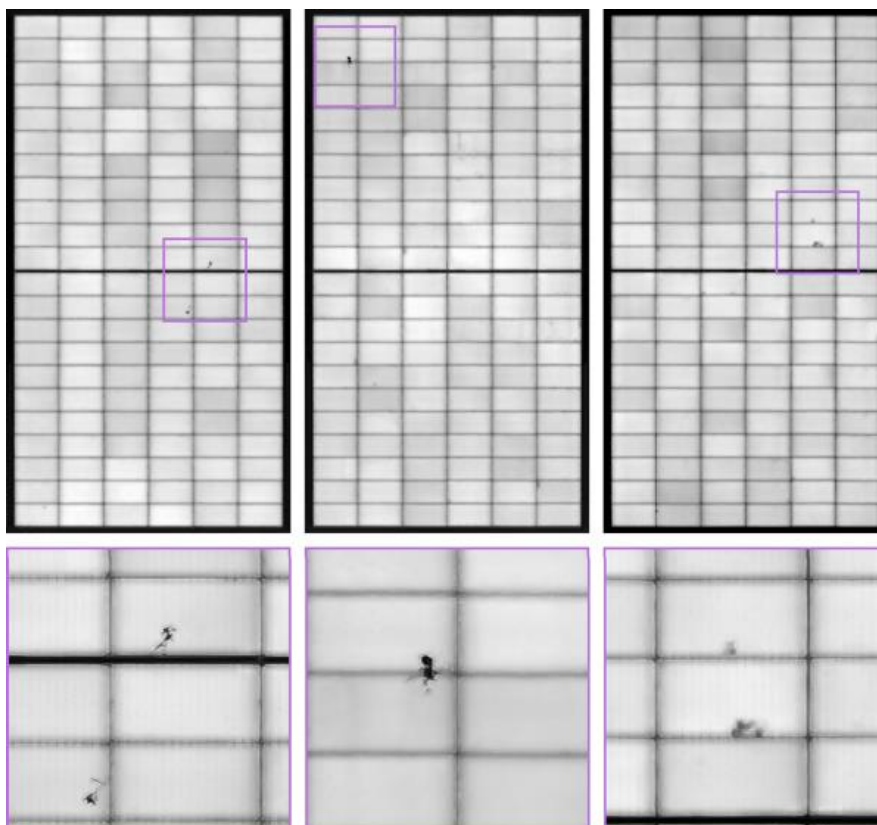
**Five modules:** two in R01, two in R12 and one in R06. The source describes short crack-like lines or branches confined to one or two cells per module and reports no isolated cell fragment in the assessed examples.

Figure 5. Source module examples above; enlarged details below. Existing source annotations are retained.

These findings warrant review as cracked-cell indications. Image appearance alone does not establish when the damage arose or whether manufacturing, handling, installation, operation or another mechanism was responsible. The associated power impact has not been quantified.

Review the full-resolution images, preserve the baseline and repeat imaging under comparable conditions where monitoring is appropriate. Use suitable electrical measurements when a performance assessment is needed. The responsible technical reviewer should set the follow-up timing from site conditions and corroborating evidence.
